Changes to the functioning of a mountain stream following installation of boulder riffles and check-dam lowering: Krzczonówka Stream, Polish Carpathians

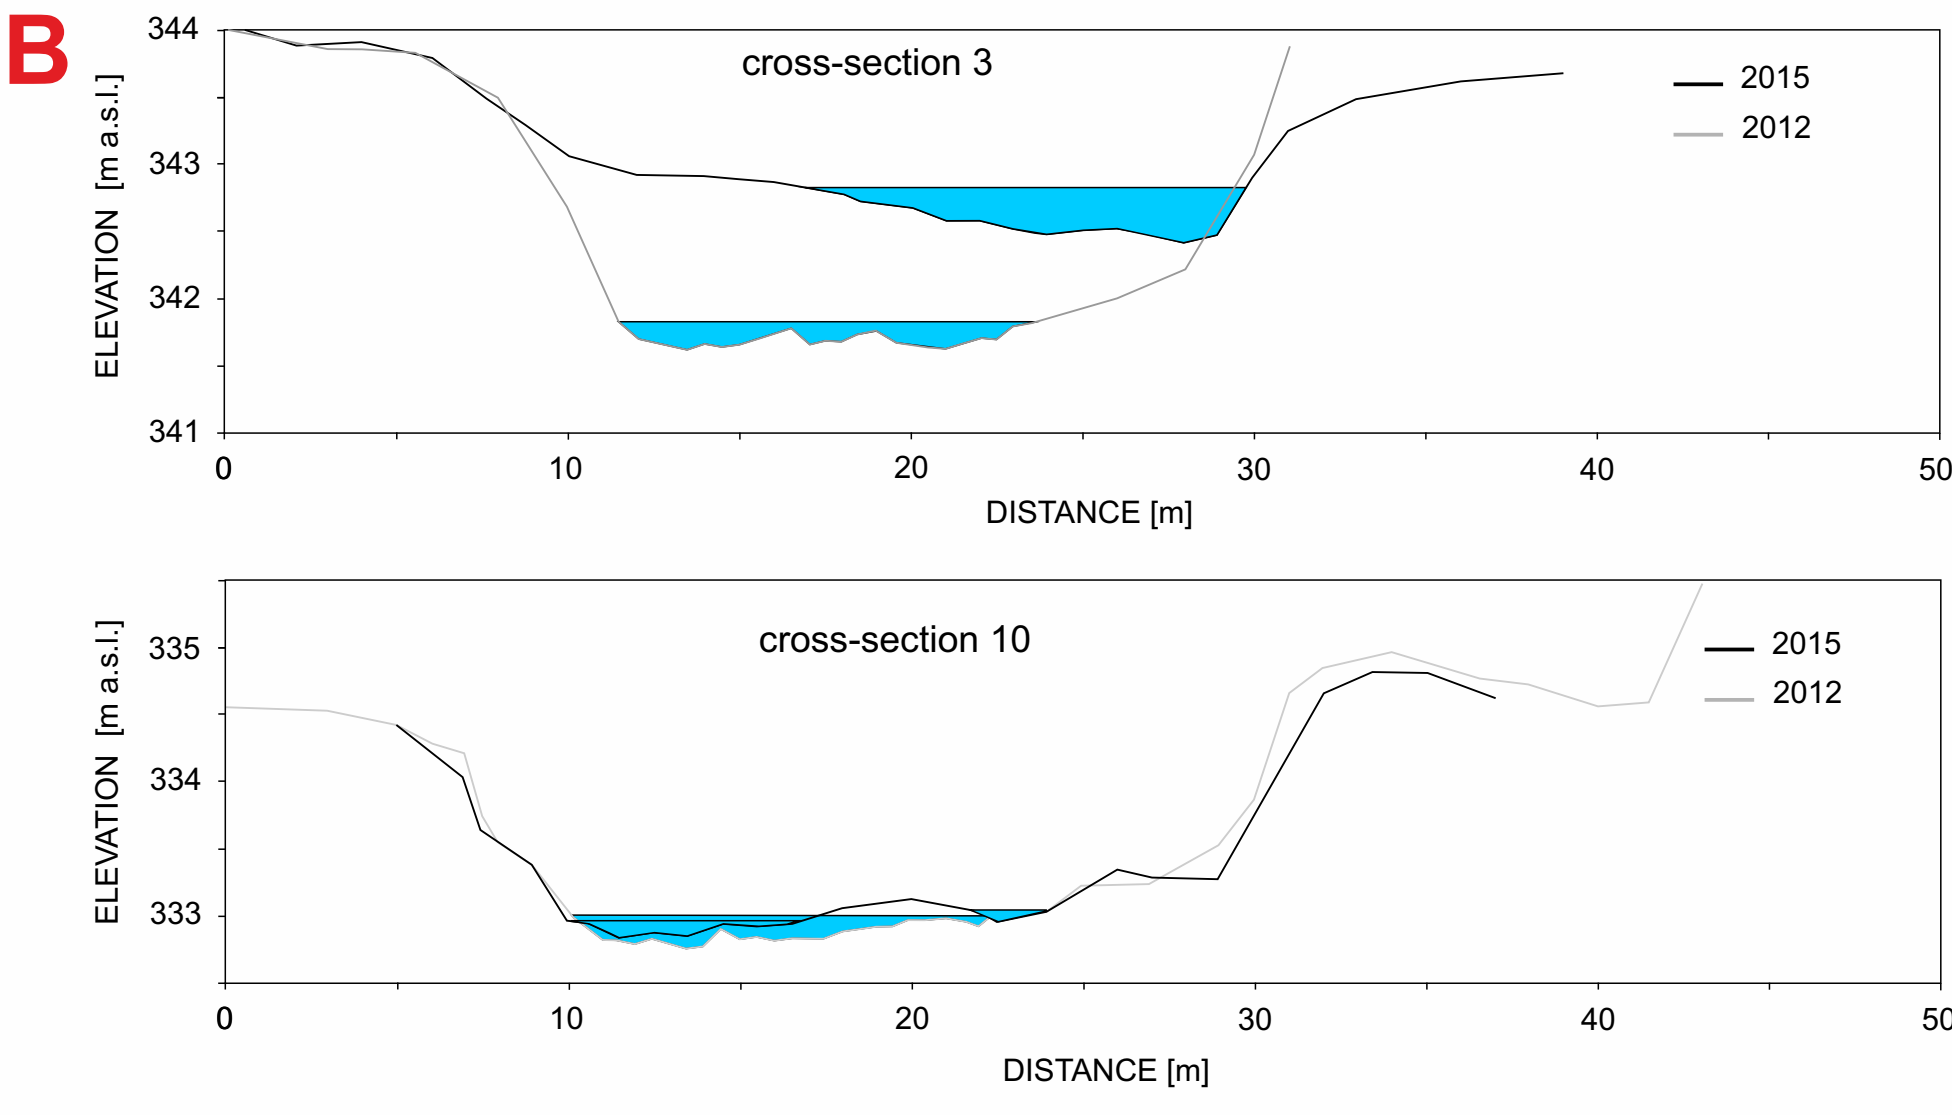
2 (A) Change in the elevation of low-flow water surface and mean elevation of channel bed in the investigated cross-sections between 2012 and 2015. (B) Examples of cross-sections in the proximal (upper) and distal (lower) parts of the sediment wave in the stream reach downstream of the lowered check dam.

The material delivered to the lowest reach of Krzczonówka Stream by the flood of May 2014 was efficiently trapped by the installed boulder riffles which became buried on the distance of ca. 1.2 km from the check dam, whereas the sediment wave reached 1.6 km from the dam. About 14000 m³ of bed material were retained in the stream, with an average increase in bed elevation amounting to 0.37 m. A maximum increase in the average elevation of bed surface equaled 0.72 m at a distance of 470 m from the dam, whereas a maximum increase of low-flow water surface reached 1 m.

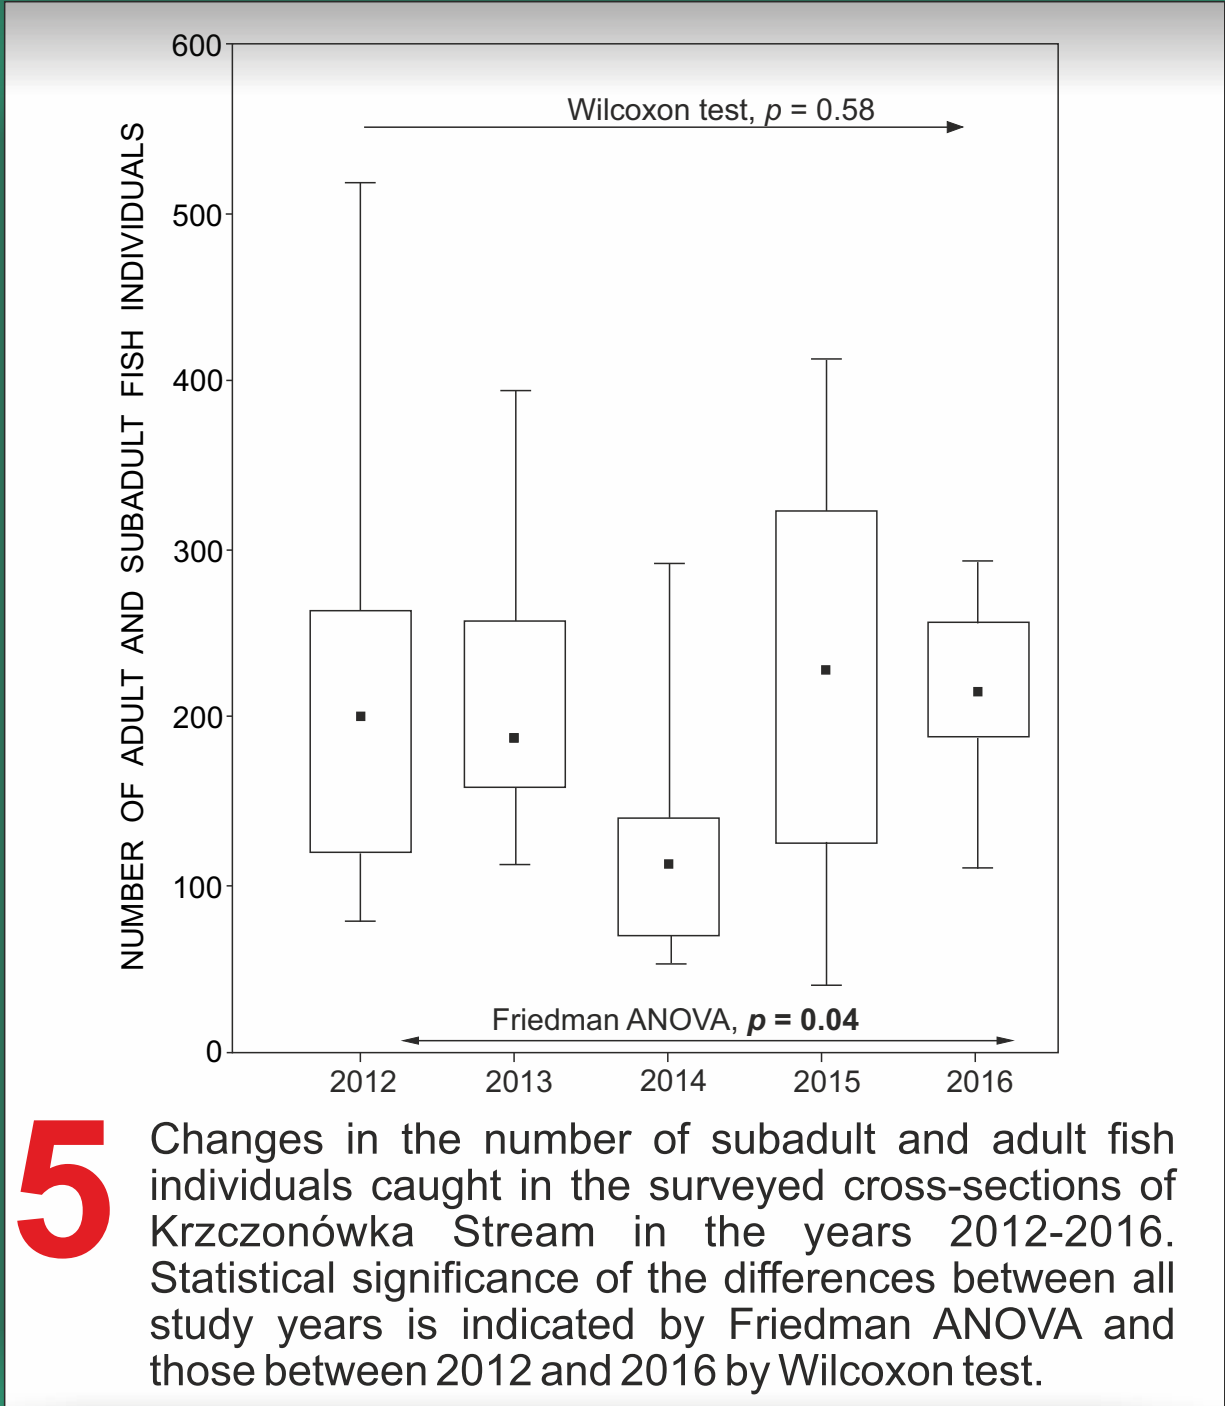
5 Changes in the number of subadult and adult fish individuals caught in the surveyed cross-sections of Krzczonówka Stream in the years 2012-2016. Statistical significance of the differences between all study years is indicated by Friedman ANOVA and those between 2012 and 2016 by Wilcoxon test.

The assessment of hydromorphological quality of the stream performed in 2012 and 2015 indicated its improvement in 4/5 of the evaluated cross-sections, reflected in a shift to a higher quality class for 3/5 of the evaluated cross-sections. The average number of fish individuals, especially juveniles, in a stream cross-section decreased in the years with the installation of boulder riffles, lowering the check dam, and the large flood (2013-2014) but returned to the initial values in 2015. The average number of macroinvertebrate taxa in a cross-section decreased in the year with the works to lower the check dam and the large flood, but since 2015 it has increased to a greater number than before the restoration works.

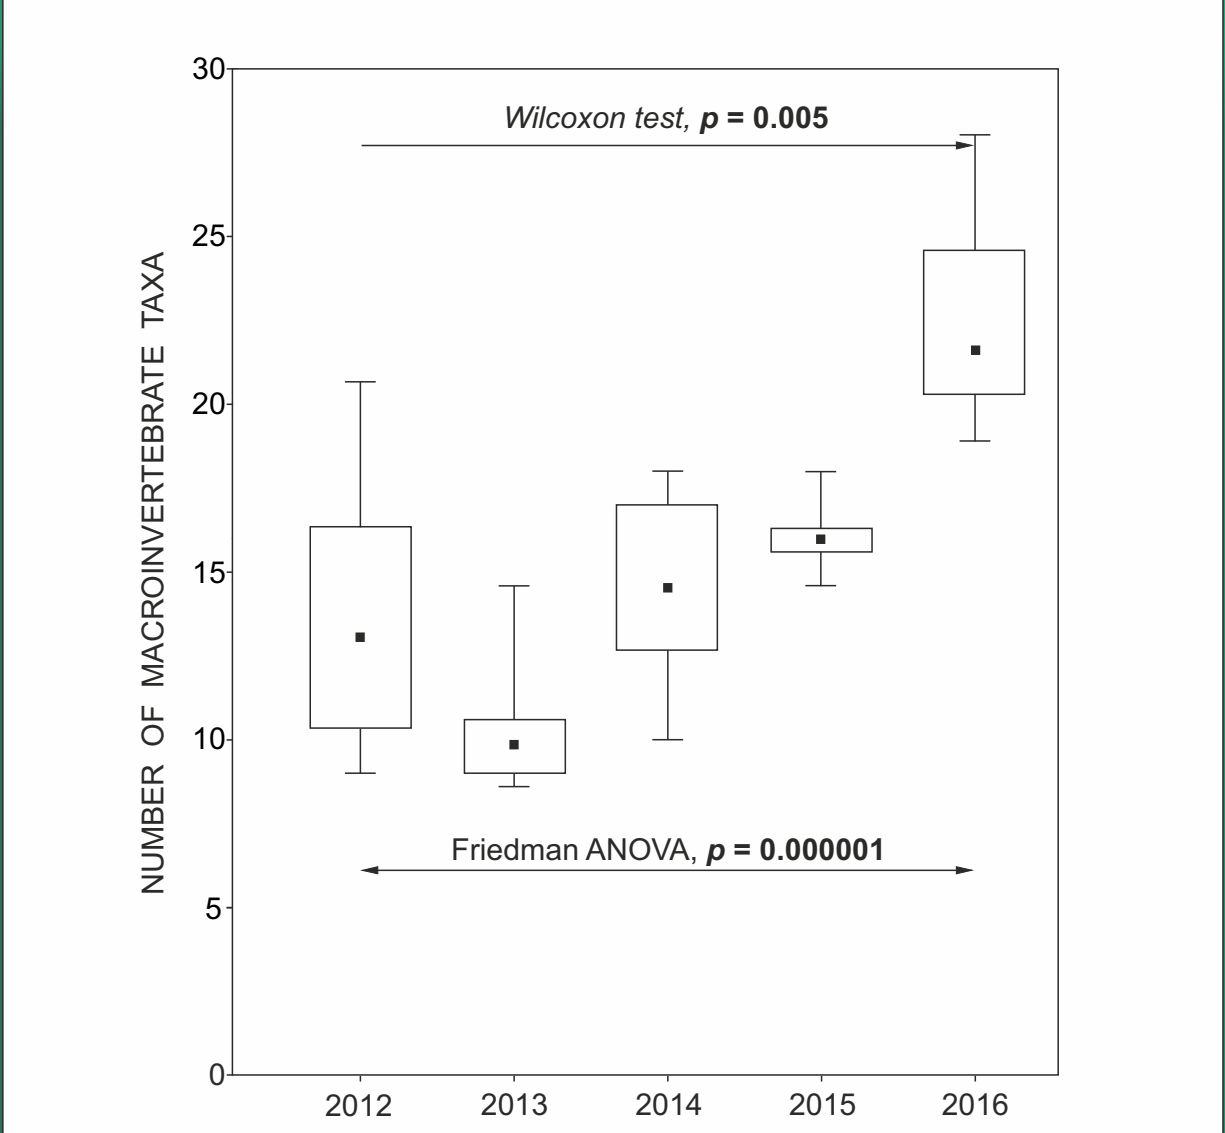
6 Changes in the number of macroinvertebrate taxa in the surveyed cross-sections of Krzczonówka Stream in the years 2012-2016. Statistical significance of the differences between all study years is indicated by Friedman ANOVA and those between 2012 and 2016 by Wilcoxon test.

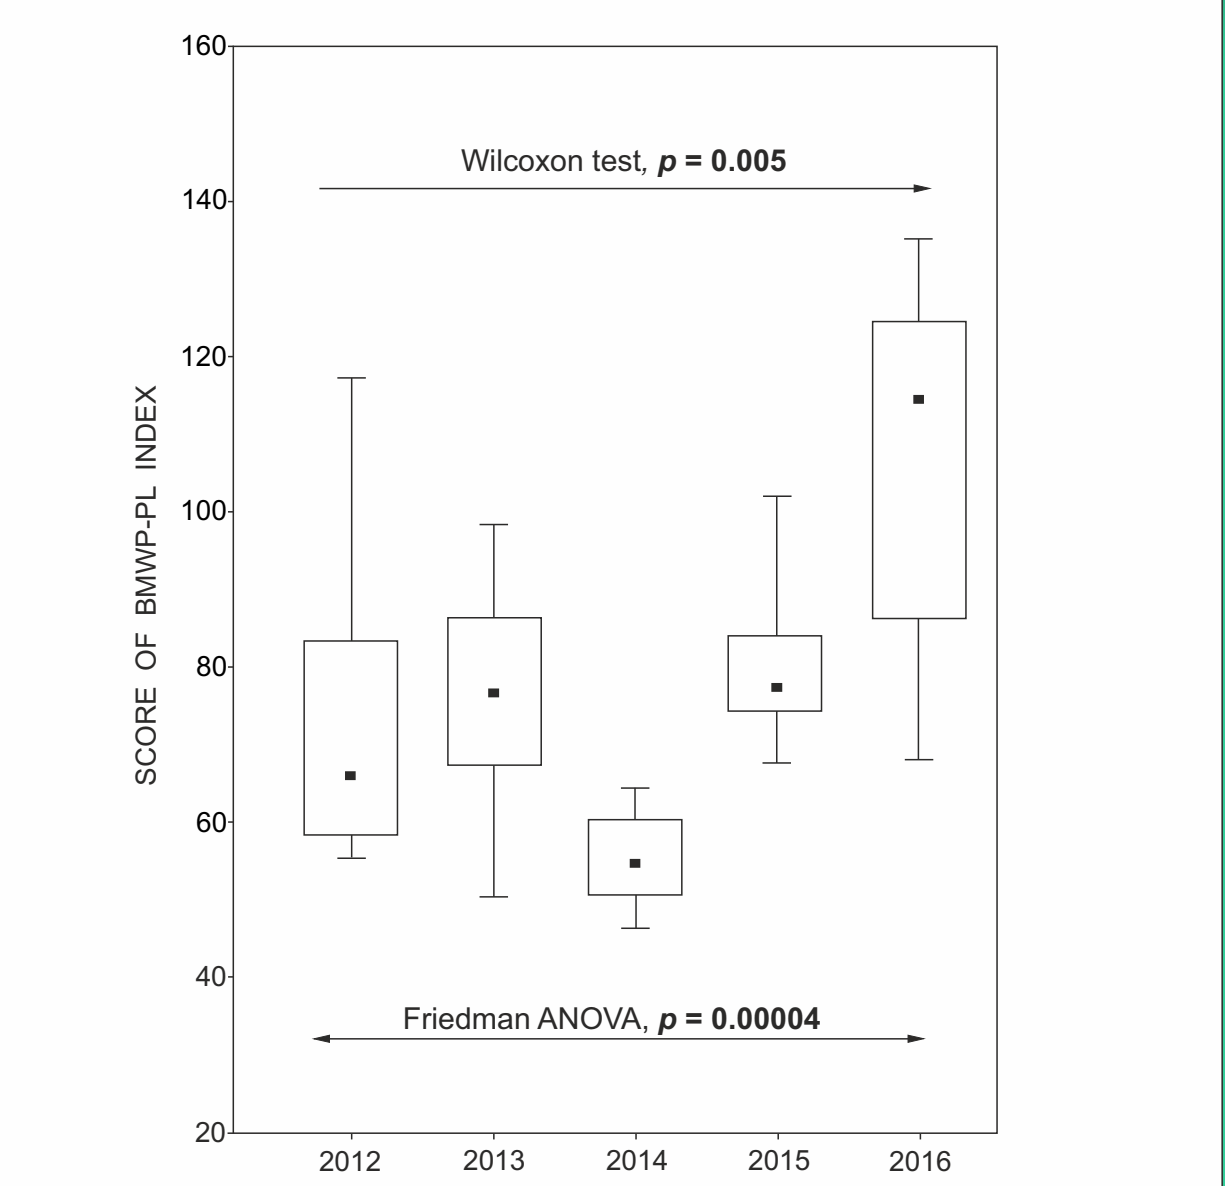
7 Changes in the scores of macroinvertebrate-based BMWP-PL index calculated for the surveyed cross-sections of Krzczonówka Stream in the years 2012-2016. Statistical significance of the differences between all study years is indicated by Friedman ANOVA and those between 2012 and 2016 by Wilcoxon test.

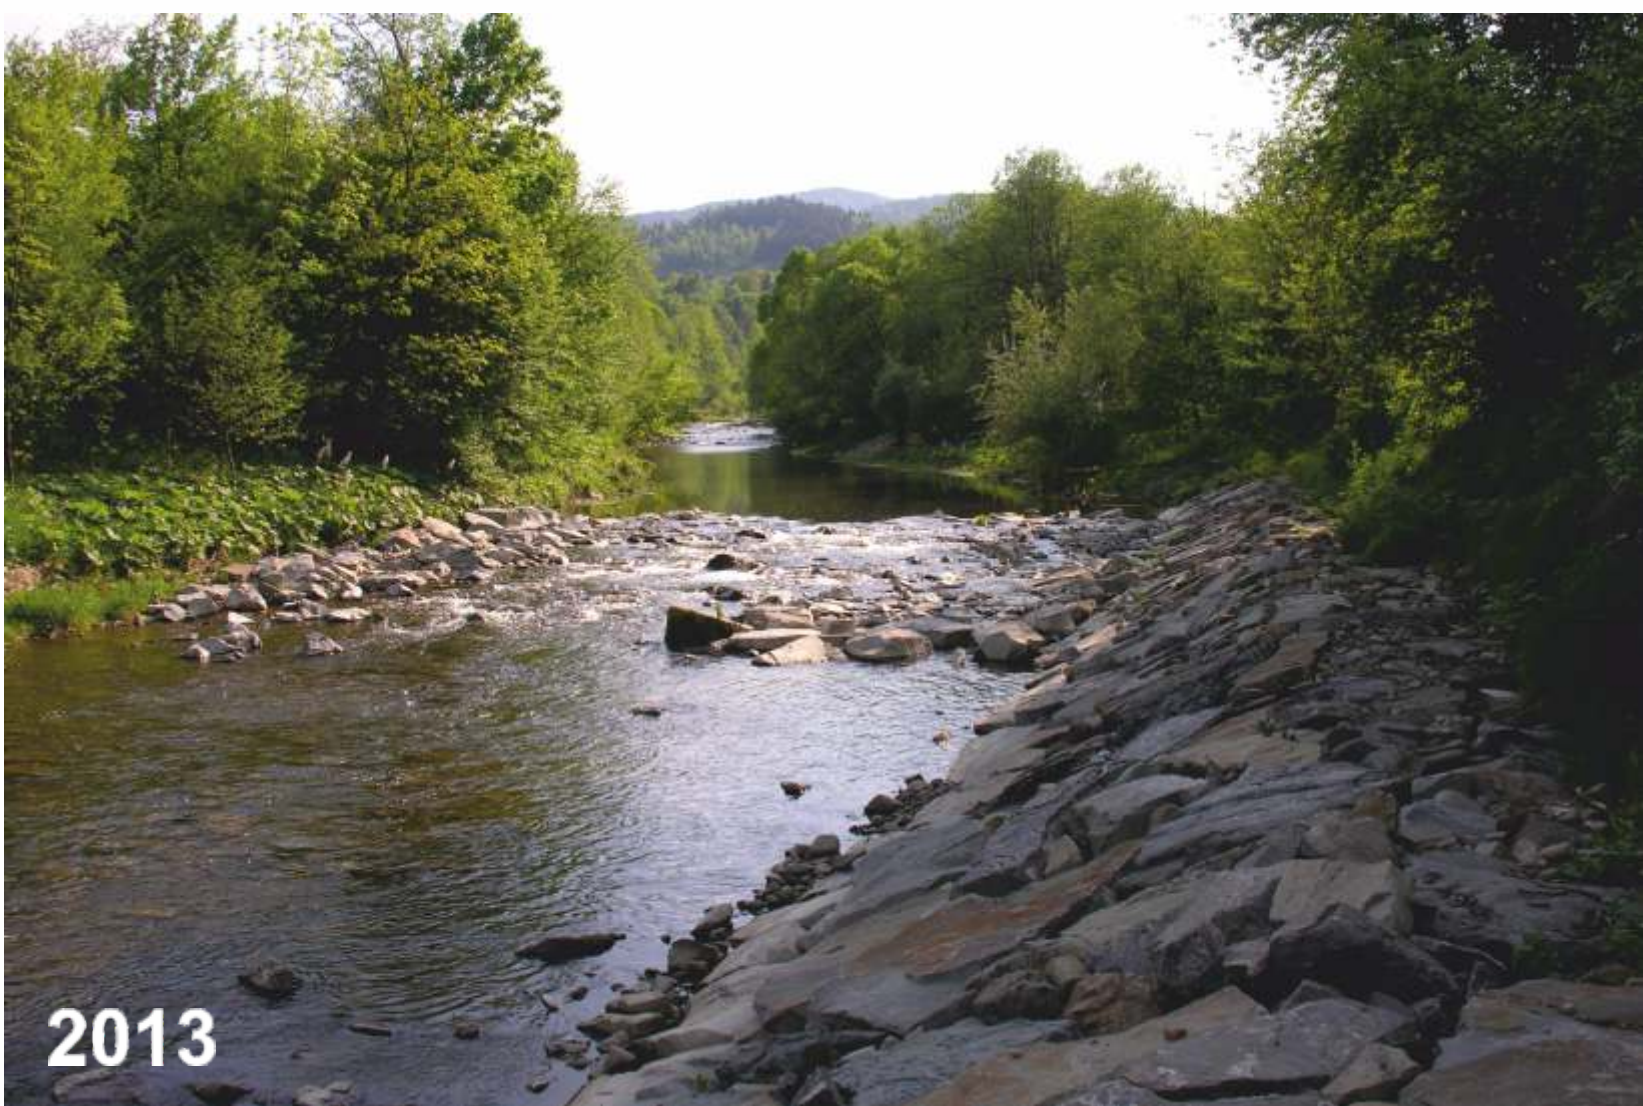
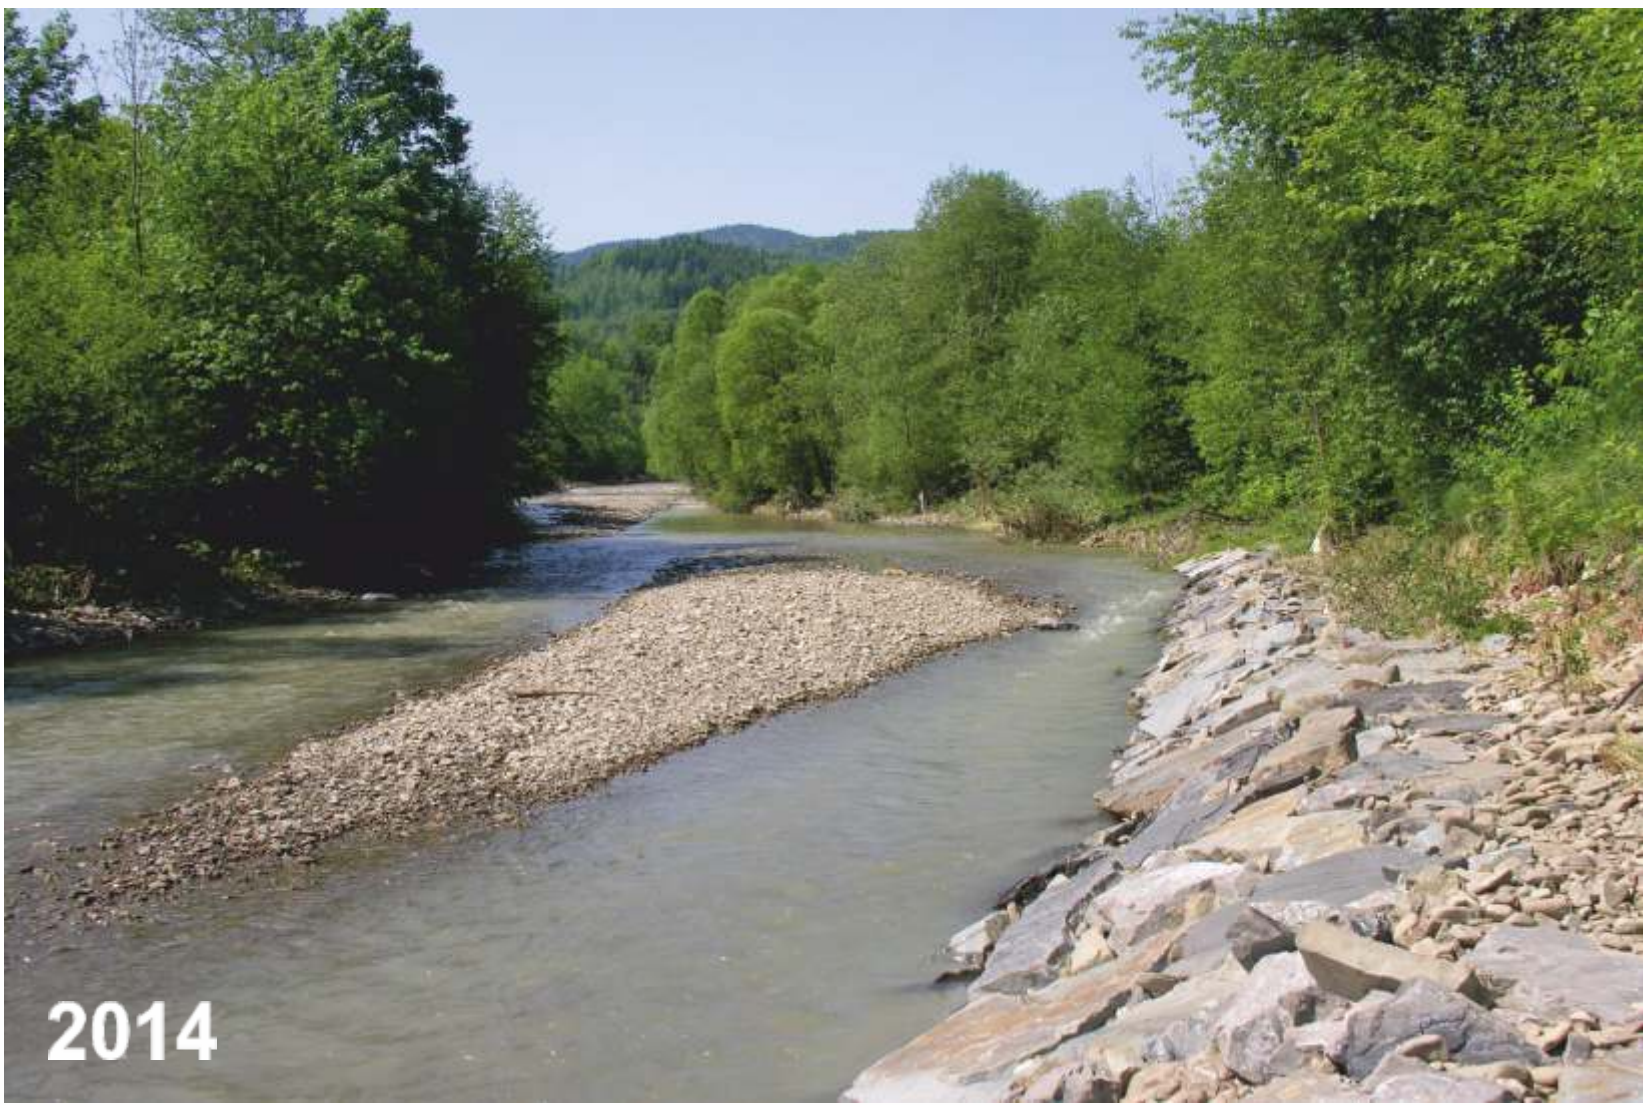
4 View of Krzczonówka Stream with an installed boulder riffle (2013) and after the passage of the flood of May 2014. Visible entrapment of considerable amount of gravel and burying of the boulder riffle.

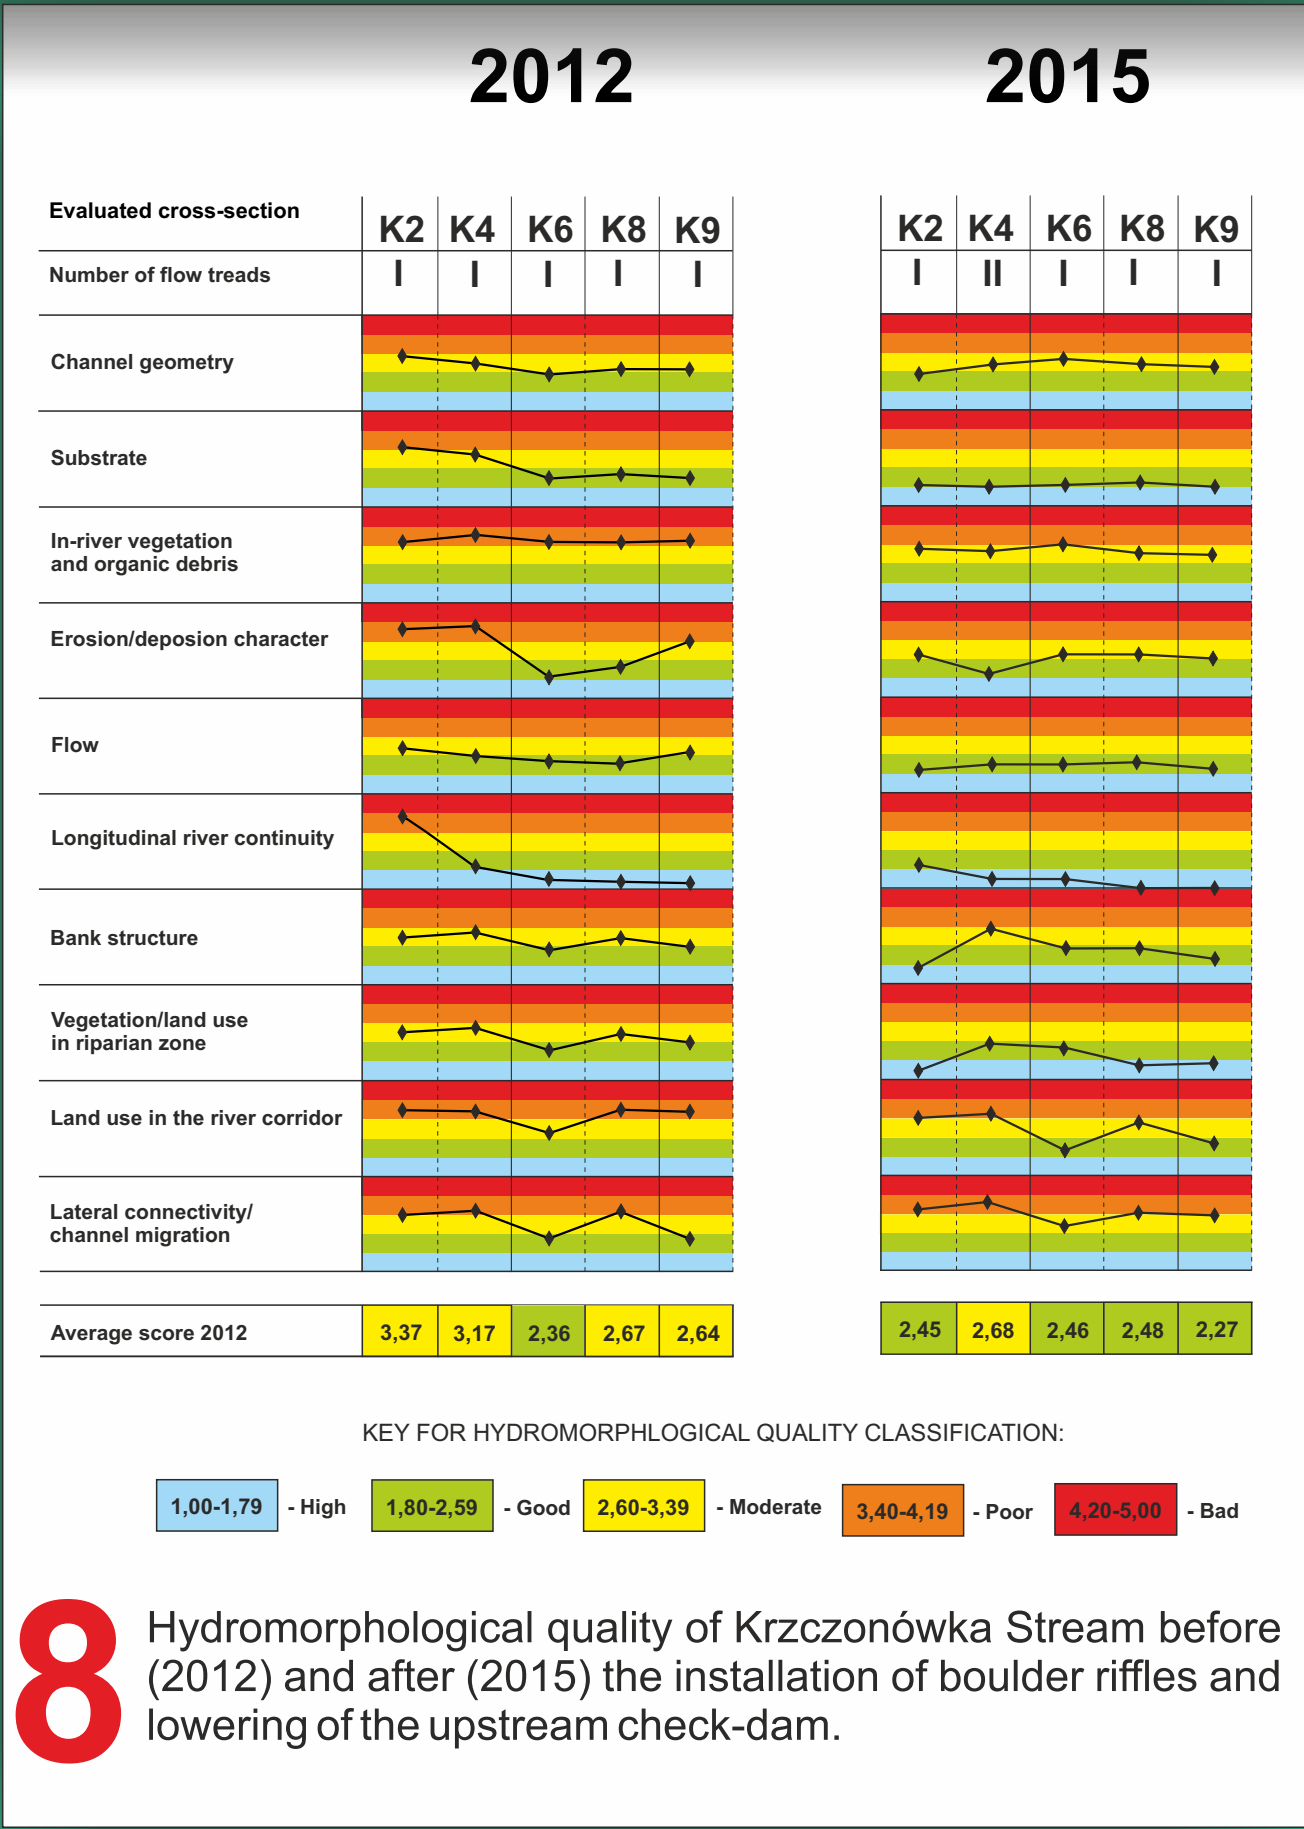
8 Hydromorphological quality of Krzczonówka Stream before (2012) and after (2015) the installation of boulder riffles and lowering of the upstream check-dam.

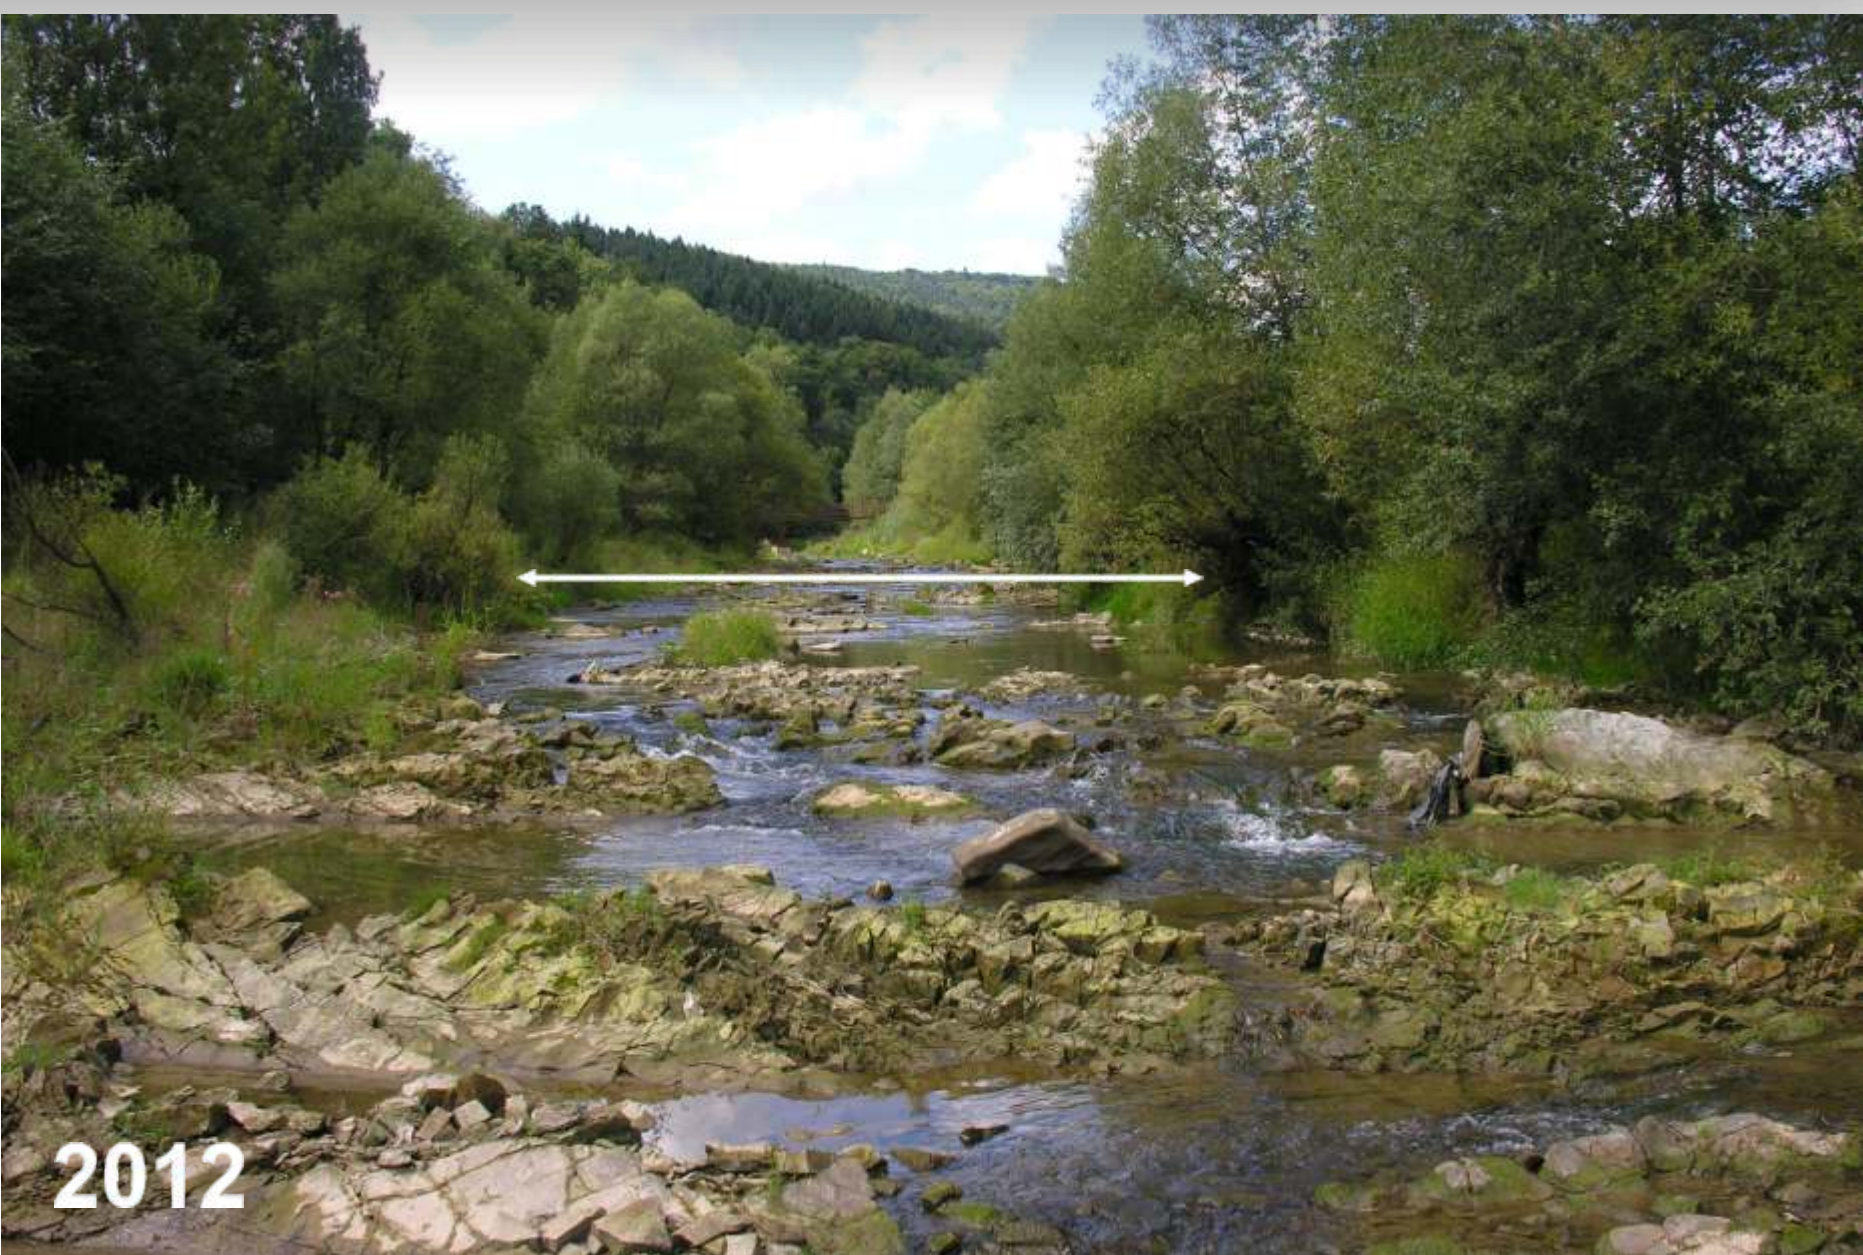
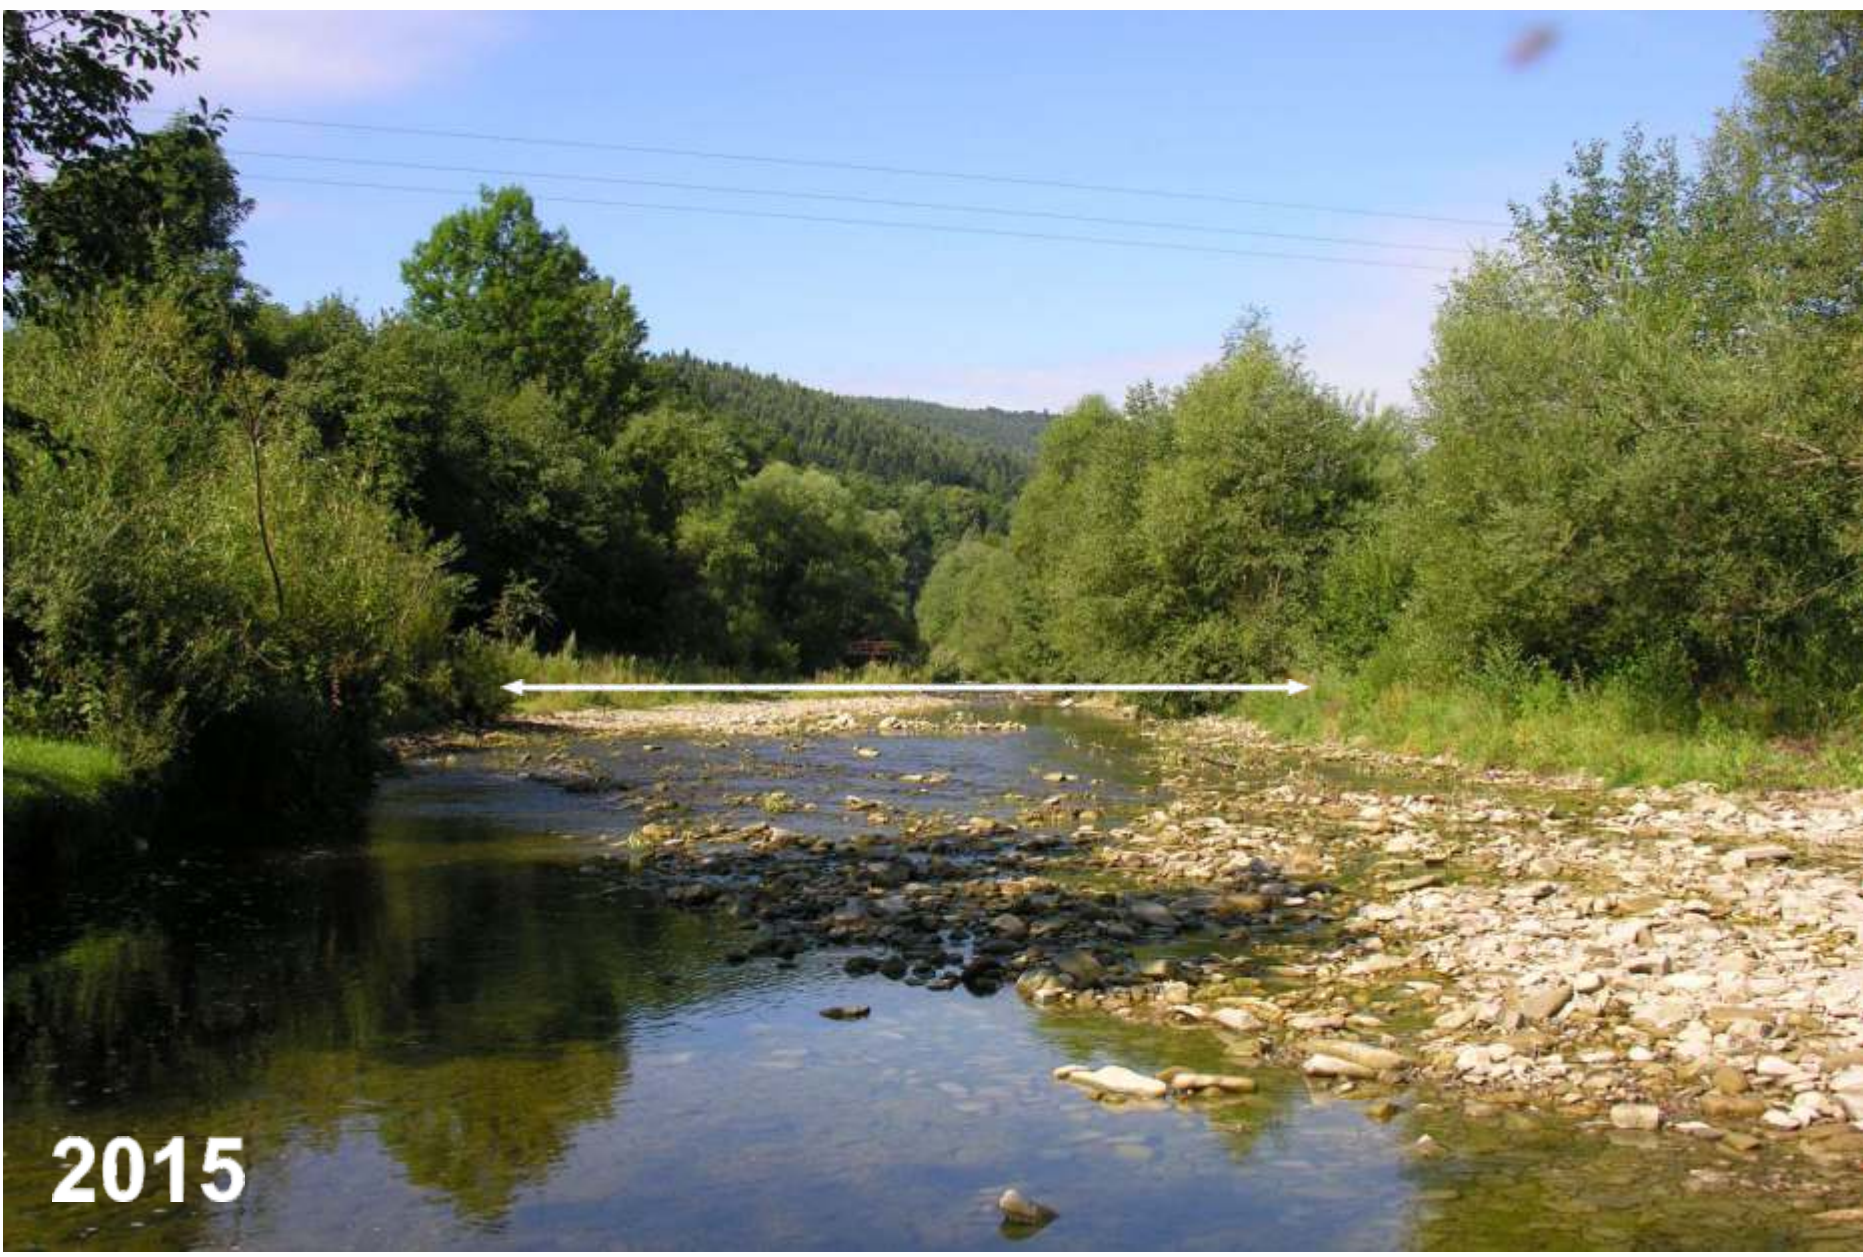
3 View of Krzczonówka Stream in the vicinity of cross-section 3 before (2012) and after (2015) the installation of boulder riffles. Visible change from bedrock to alluvial boundary conditions as a result of gravel deposition in the channel.
